Modifying Existing Post-Tensioned Concrete Structures

Shown below is a project in which Dutchland, Inc. was contracted to add a sluice gate into an existing post-tensioned wastewater treatment plant.

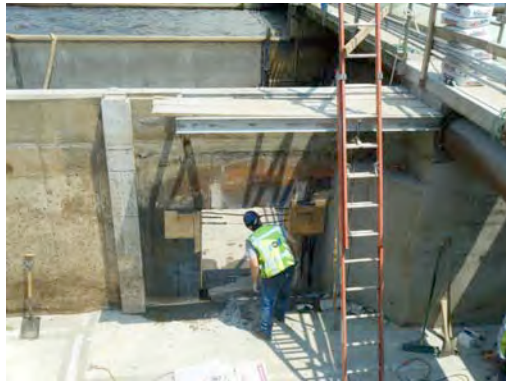
Rough opening cut into wall.

In 2012, the Ephrata Borough Authority added an outside ring to an existing oxidation ditch originally constructed in 1982. The modified wastewater process upgrade required the installation of a 4-ft by 4-ft sluice gate into the existing 10-ft tall post-tensioned wall. The tank was modified by terminating the post-tensioning strand at the opening and adding make-up tendons to the wall above the opening in the structure. The tank modification was completed in 72 hours.

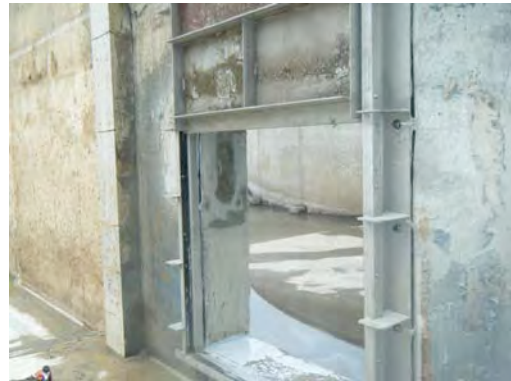
Installed sluice gate.
